TITLE	QM Vibration Functional Test
DOCUMENT TYPE	REPORT
DOC No.	AMST/ACQFV/1/A
ISSUE No.	1
DATE	27/01/06

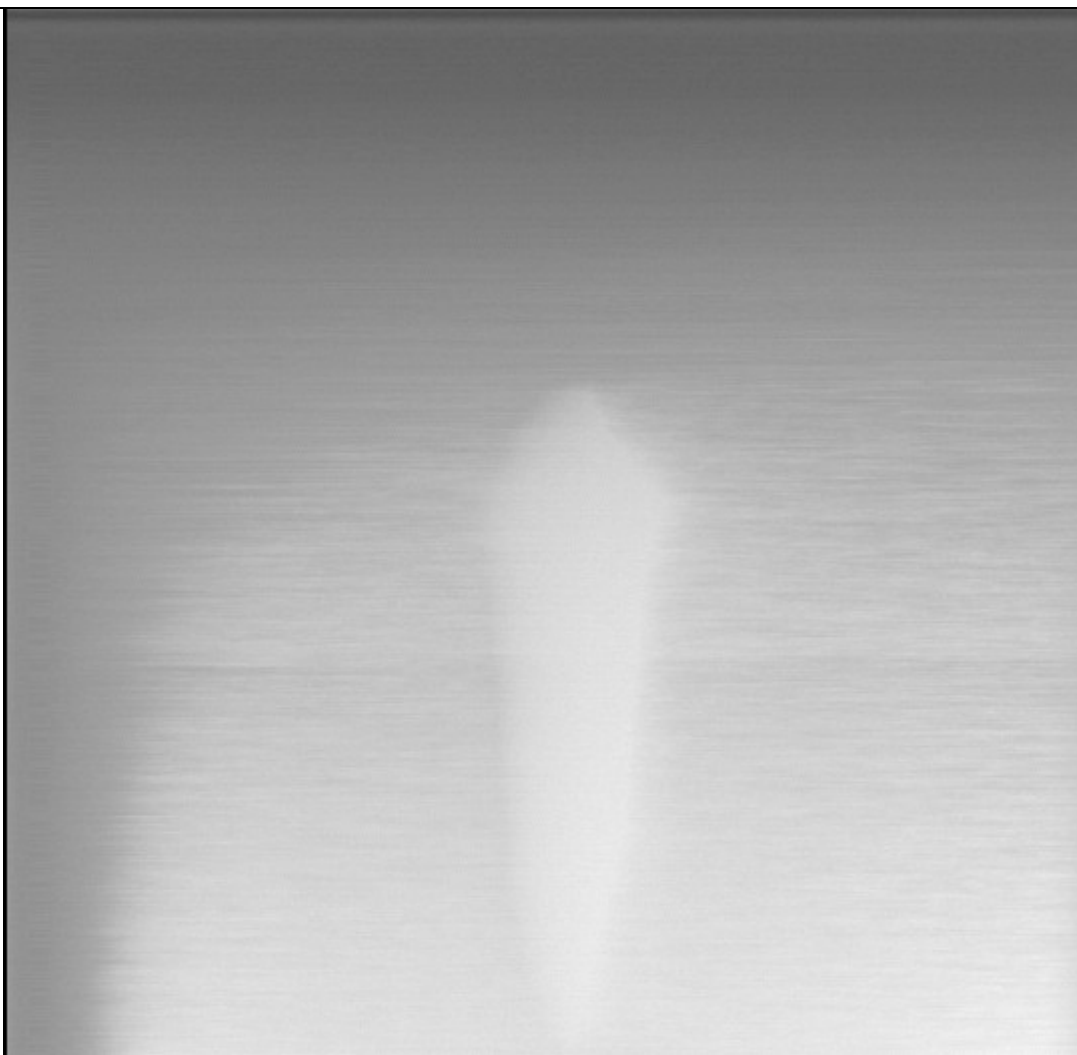
The result of the careful inspection and testing was that after the vibrations everything behaved exactly as before.

The vibrational test had no impact on the functionality of the AMICA electronics, as can be seen in the following picture taken after the camera inspection.

Image of a bright spot, taken in the laboratory after the camera inspection
